**SITE ASSESSMENT REPORT
FOR
TILTON PLATING
TILTON, VERMILION COUNTY, ILLINOIS
TDD No.: 505-9809-012
PAN: .8P1201SIXX**

December 1, 1998

**Prepared for:
UNITED STATES ENVIRONMENTAL PROTECTION AGENCY
Emergency Response Branch
77 West Jackson Boulevard
Chicago, Illinois 60604**

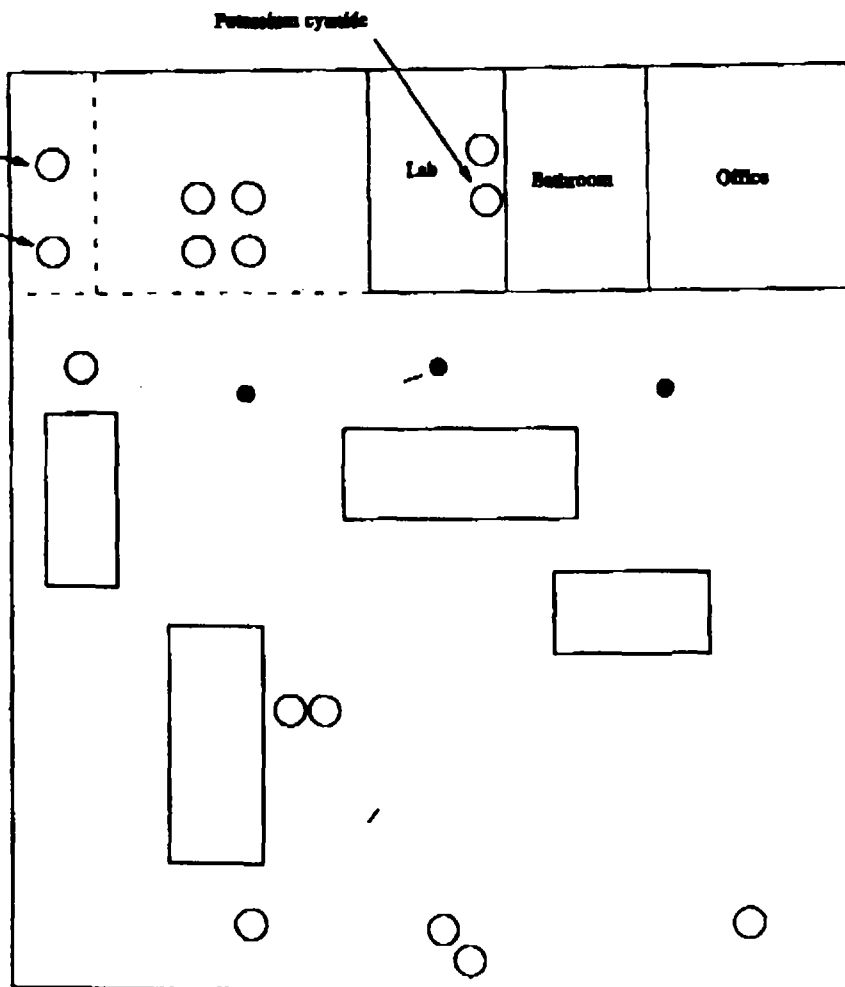
TITLE Building Features Map		FIGURE 3-1	
SITE Tilton Plating		SCALE Not to scale	
CITY Tilton	STATE Illinois	TOP S05-9809-012	
SOURCE Ecology and Environment, Inc.		DATE October 6, 1998

During a second entry into the building, START photodocumented and videodocumented hazards present inside the building. An inventory was taken of hazardous materials in the building (Table 3-1). The northwestern corner of the building contained a storage area. East of the storage area was a

laboratory. There was evidence of the roof leaking in the building, as one vat was filled with rainwater. Three drains were observed in the floor of the building. One drain was believed to lead to a sewer; it is unknown where the other two drains lead. Soil was visible under one of the drains.
